SETTING THE RECORD STRAIGHT #6

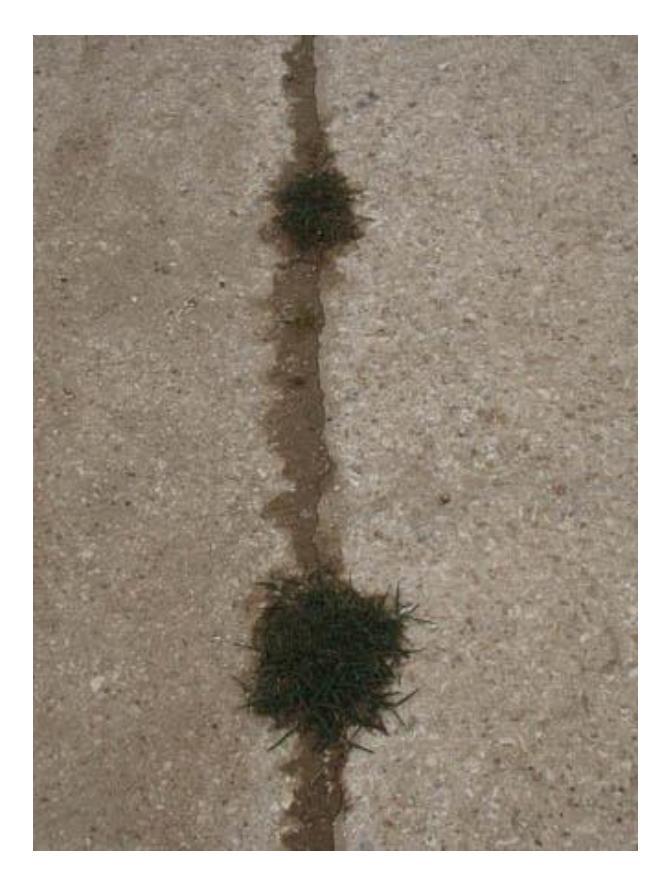
So what of the boating lake? Take it as a structure; it was built from concrete in the late 1930's when engineering standards were not what they are today. The floor is cracked in many places and both leaks water when it is filled, and flushes out soil from underneath when the surrounding ground is saturated and the water table high (as occurred over last winter). It has partially collapsed in the NW corner, where a large puddle accumulates after rain. When contractors were patching the holes drilled by the EA, they commented to us how surprisingly thin the bottom was. We recently posted video of air bubbles escaping up through the lake bed from underneath where void spaces have been created through subsoil collapse. The side walls are also severely cracked and leaking. This winter you could see water pouring out. The joint between the side walls and the capping is also cracked and leaks water. Critically, the walls are also now collapsing in at significant angles, on both the long edges. One of the attached photos show the eastern edge, the western edge is actually worse. The simple fact is that it is 75 years old and time has taken its toll and it is now completely worn out and breaking apart. We very much doubt if Sir Sydney Kimber would have expected it to still be around today.

water seeping up through cracks in the lake bed

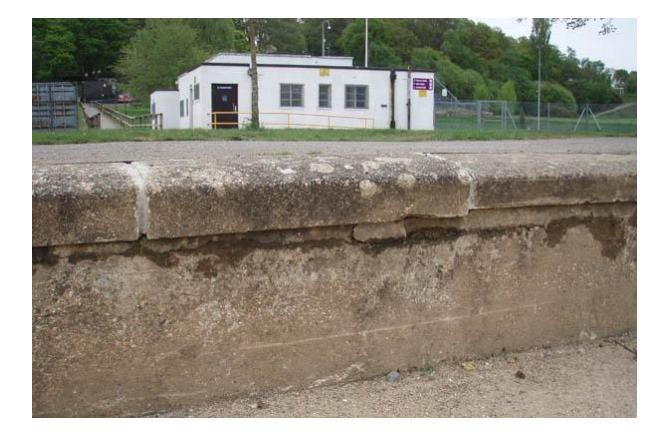
water seeping in through cracks between walls and capping

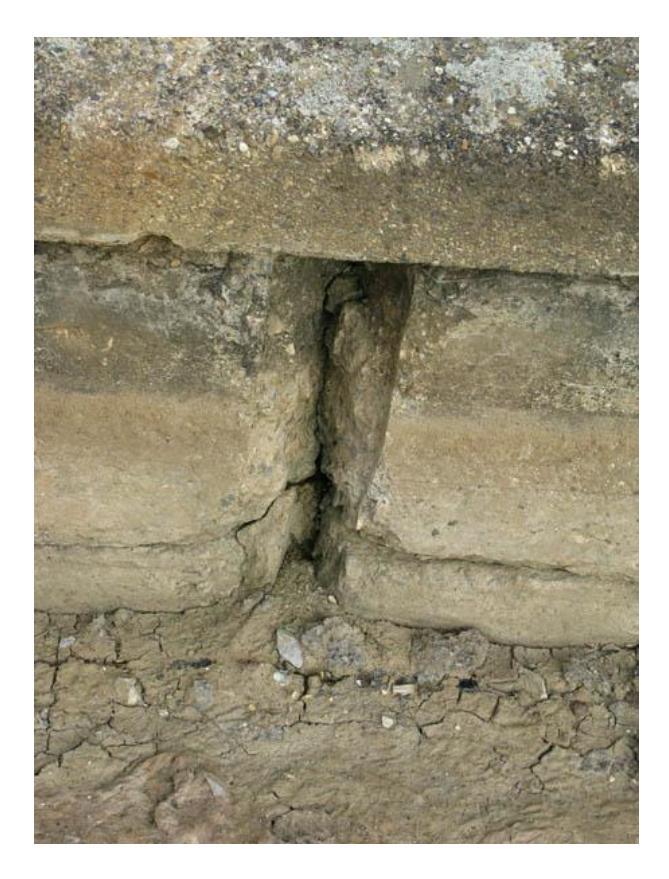
cracked side walls

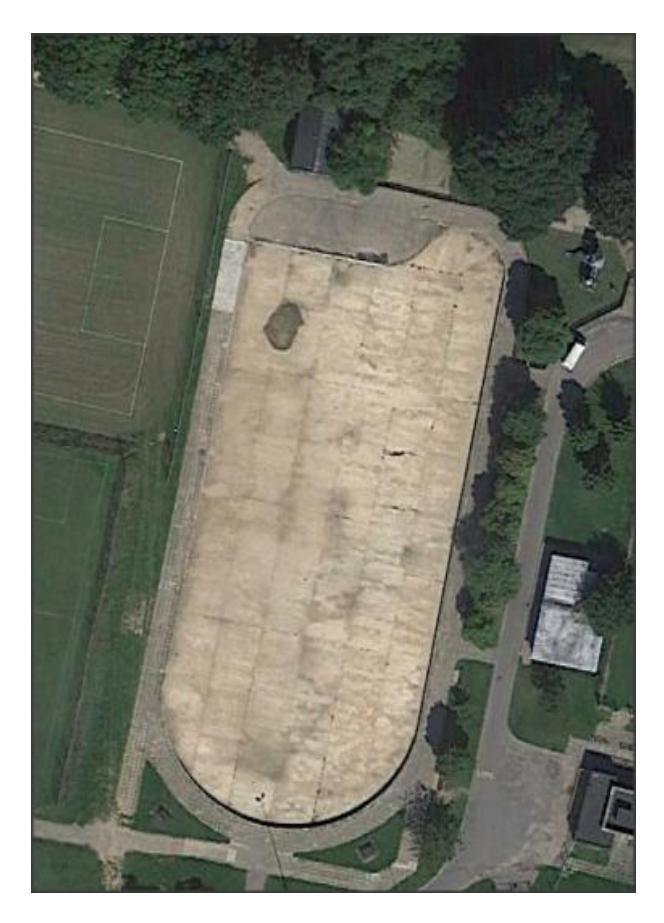
puddle in collapsed area in NE corner

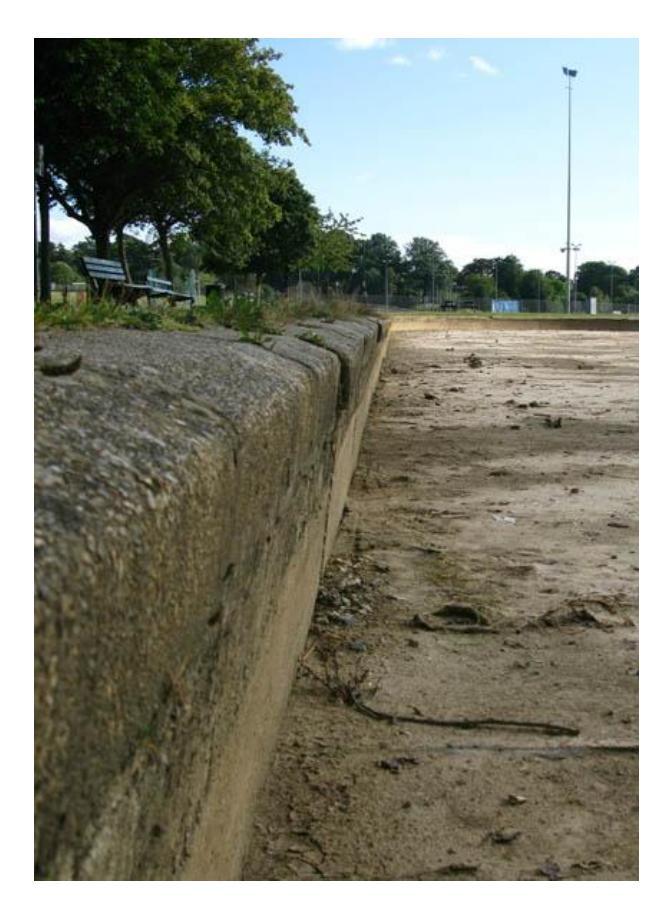
side walls sloping in
